**Borough of Bellefonte
Kepler Pool
Bellefonte, PA
Pool Conditions Assessment & Feasibility Study**

RE Conditions Assessment/Feasibility Study for
The Kepler Pool Complex

Executive Summary

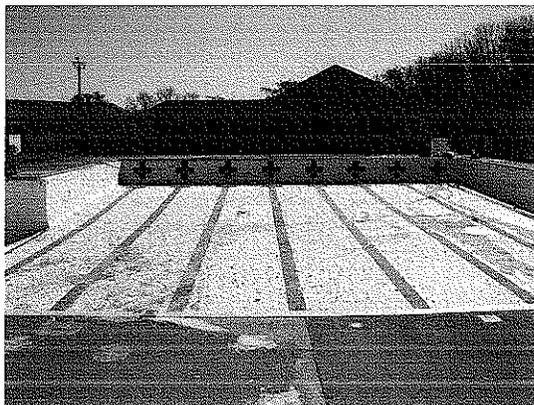
Figure 1

There are eight (8) competition style race lanes. **These are constructed to 25 yards competition length.** See Fig. 1. There is a series of stainless steel ladders for access and 5 wooden lifeguard platforms. A handicapped chair lift is present on site for patron use. A poured concrete deck surrounds the pool. See Fig. 2. **No play type or other general recreational amenities exist.**

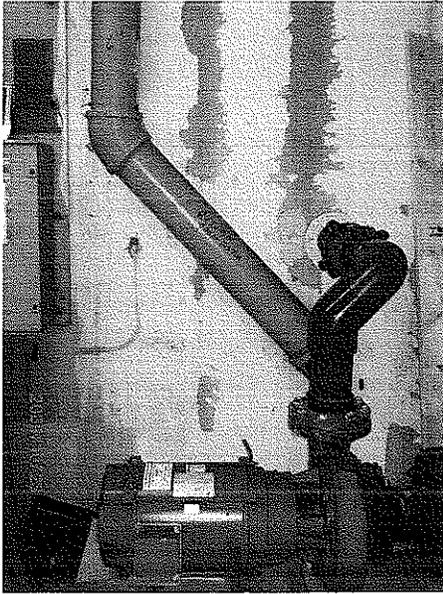
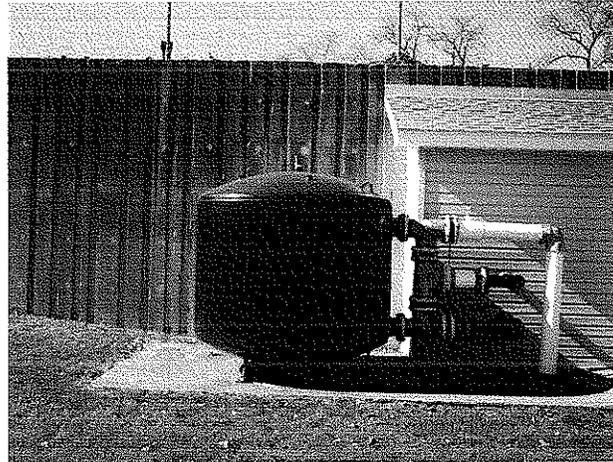
The Main Pool filtration system consists of a gravity fed recirculation pump and motor linked to a single tank pressure sand system. See Fig. 3 & 4 page 23. The filter tank is steel with manual setting controls. This system also serves the Wading Pool, which has no filtration of its own. The chemical system consists of a Liquid Chlorine system for sanitation and a Muriatic Acid system for pH regulation. This system also services the Wading Pool. These units are computer regulated. The Filtration and Chemical Systems are located at the deep well end of the pool. They are below grade. The Filter is exposed to the elements and to the public with no enclosure. The Filtration pump,

valving and controls, as well as the chemical system, are housed in rooms below and adjacent the deep well decking.

A new Filtration System consisting of a pressure DE type system is recommended for the newly reconfigured pool. This system is more efficient in a multi-use pool than the current pressure sand system.

A U.V. System, in conjunction with a bulk Liquid Chlorine System for sanitation, as well as, a CO2 System for pH adjustment, is recommended. Sanitation systems will be controlled and dispensed by a computerized system.

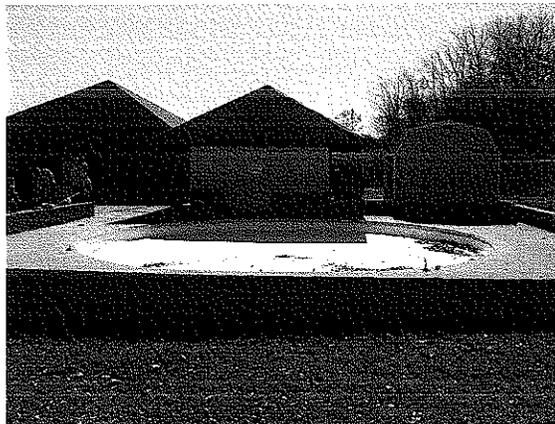
Figure 5

The Wading Pool was constructed in 1971. It is believed to be constructed of steel reinforced shotcrete type concrete. Due to the specialized nature of the retrofit vinyl liner, which encases it, no Core Borings were performed. It is a Circular configuration. The pool consists of approximately 707 sq. ft. of surface area. The pool has an underground recirculation piping system consisting of a series of sidewall intake boxes, a sidewall filtered water return system, and a single bottom drain intake box. Underground piping appears to be a combination of PVC and steel composition. A poured concrete deck surrounds the pool. The pool structure, as constructed, is **NON-ADA COMPLIANT**. No amenities exist. See Fig. 5.

The existing Wading Pool, although believed to be structurally sound, is inappropriately located for an efficient inclusion into a Complex Reconfiguration Plan, as this area is required for the construction of the new Zero-Entry Addition. Additionally, its dependence upon the Main Pool recirculation and sanitation systems, result in a violation of PA Dept. of Health turnover rate and sanitary codes.

It is therefore Recommended the Wading Pool be Removed.

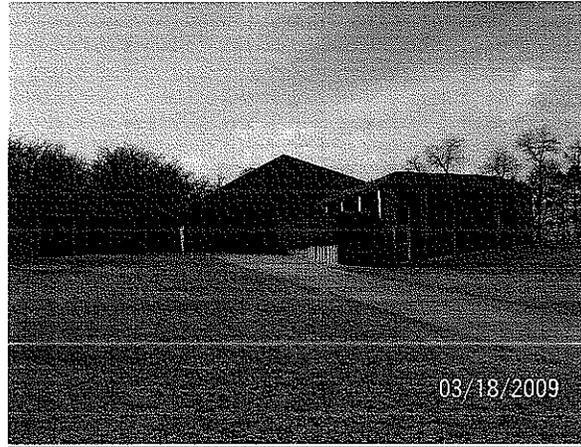
Figure 6

C. Bathhouse Building – See Fig. 6

Existing sloped sidewalk leads from the parking area to the Bathhouse structure.

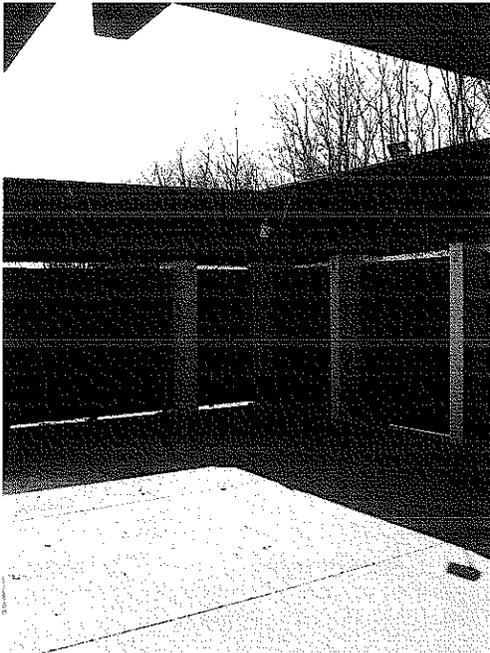
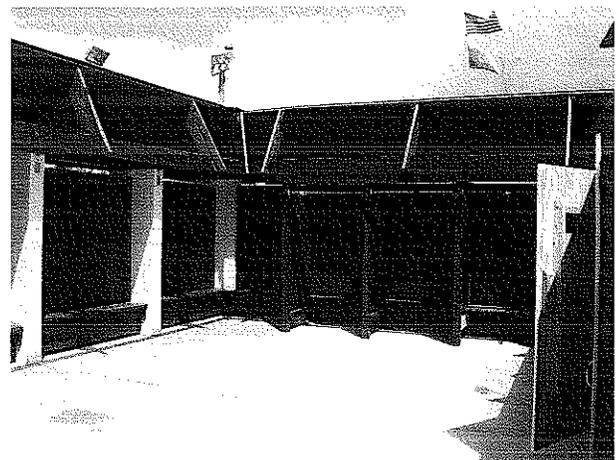
The existing building is a slab on grade, square steel post and beam structure with a shingled roof. The building is of **open-air design** with Men's and Women's changing areas protruding from the Main Structure. See Fig. 7 & 8.

The interior spaces although primarily ADA Compliant are patron unfriendly due to the small quantity of fixtures available. Most importantly, the open-air design leads to unsanitary conditions, primarily caused by birds, making janitorial type maintenance extremely difficult. Additionally, the areas, which are constructed completely in the elements (not under roof), are subject to accelerated deterioration.

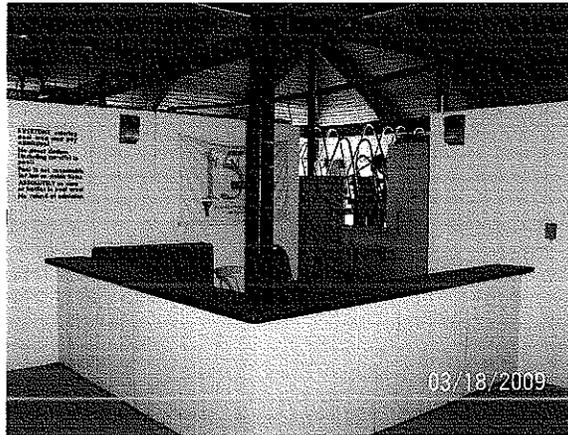
Figure 9

- General Admissions Area
 - This space contains a foyer area and a service/ticket counter. See Fig. 9

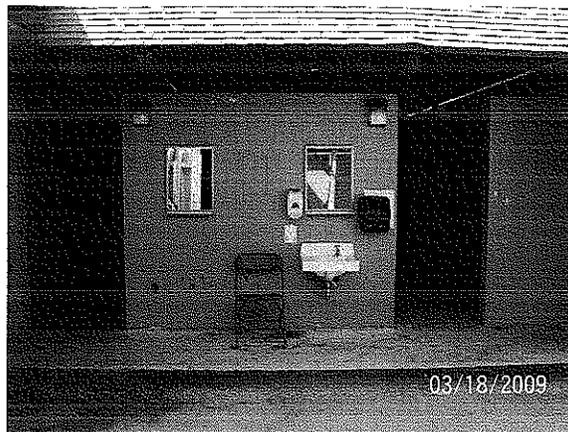
Figure 10

- Separate Men's and Women's Changing Room, Toilets, and showers
 - The Men's and Women's toilet areas are under roof with the Men's and Women's changing areas being completely exposed to the elements.
 - The Men's side consists of:
 - (6) Showers (one being a Handicapped Accessible type shower)
 - (1) Sink – non-ADA – a total of three sinks originally existed
 - (3) Toilets (one being a Handicapped Accessible type toilet)
 - (3) Urinals
 - The Women's side consists of:
 - (6) Showers (one being a Handicapped Accessible type shower)
 - (1) Sink – non-ADA – a total of three sinks originally existed. See Fig. 10
 - (3) Toilets (one being a Handicapped Accessible type toilet)

- Toilet fixtures, although ADA accessible, are recommended to be updated to 2004 ADA Guidelines.
- No separate or suitable Lifeguard or First Aid areas exist. General pathway areas are currently utilized.
- There are no segregated storage areas or family changing facilities.

- Replace all toilet fixtures. Provide correct fixture count as per ANSI and ADA code requirements. To consist of:
 - Water closets with flush valves.
 - Provide new shower controls and assemblies.

- Replace all toilet partitions and screens with recycled HDPE plastic partitions with anti-microbial agents. Provide new tamper proof accessories and grab bars where required. Replace all benches and changing booths with anti-microbial coated products.
- Place flooring material such as non-skid, seamless epoxy throughout building

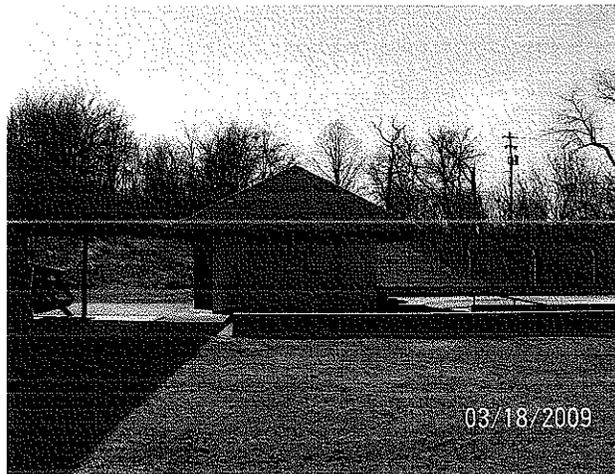
Figure 11

D. Concession Building – See Fig. 11

- Concession Building – This building is of slab on grade cmu construction
 - This space contains open ceilings. There is one (1) Service counter.

It is recommended the concession area be renovated to comply with current PA Dept. of Health regulations and to expand preparation facilities to include a variety of prepared and hot foods.

A change in Serving Window Layouts and building entry/exit points is recommended.

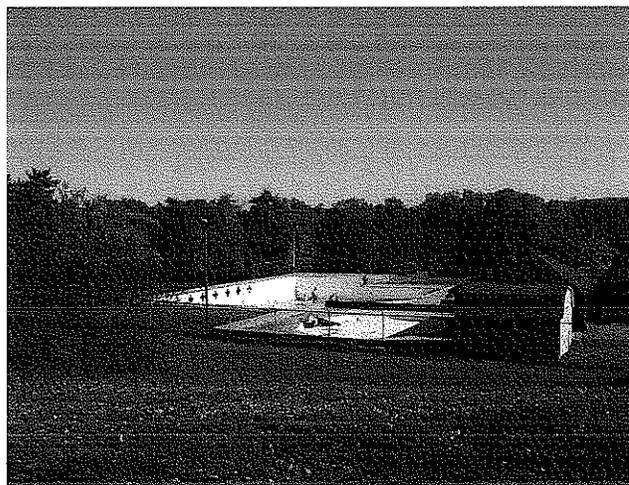
Figure 12

A perimeter chain link fence with multiple entry points contains the complex. Outside the pool perimeter deck is grass area. The deck features minimal patron benches and picnic tables. The grass area is home to a series of light standards placed strategically outside the fence for area lighting. Currently no separate pavilions or sunshade structures exist. See Fig. 12.

Optional, yet **highly recommended**, amenities such as Area Lighting, are recommended in a Phase I project. The Installation of lighting combined with heating of the water, could extend operating hours and open the facility to the possibility of revenue producing activities such as night swims or private parties. Sunshades are included in a phase one project throughout the complex.

A Phase II project may make use of construction of a Picnic Pavilion for patron usage. Construction of a Sand Volleyball court is also an option. This would require the addition of an outdoor shower adjacent the court. A new small storage shed is additionally recommended for exclusive storage of competition equipment.

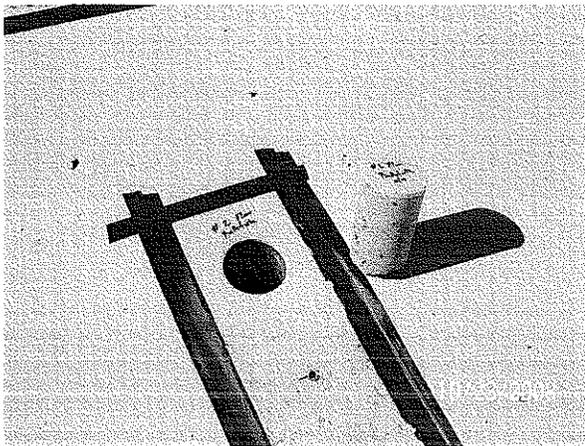
Figure 13

Floor: Three (3) 6-inch Borings were taken. The floor ranges between 9 inches and 10 inches thick. Samples indicate Steel Reinforced Shotcrete Type Concrete Construction. See Fig. 13.

Conclusion: All Borings yielded Consistent Results. **The Main Pool Structure shows no visible signs of Internal Structural decay or excessive fatigue. The shell is believed to be of Segmented Type Construction.** (This could not be confirmed due to the presence of the liner.) Although the borings indicate that the Structure is stable and accepting of Long-term Improvements and/or Reconfiguration, the Surface of the Structure is badly spalled in areas. See Fig. 15. It is theorized this was the reason for the liner installation. **Based on the condition of the surface of the shell as viewed during sampling, it is projected a completely new liner will be required to be placed in the areas of the existing pool remaining at the time of reconfiguration.**

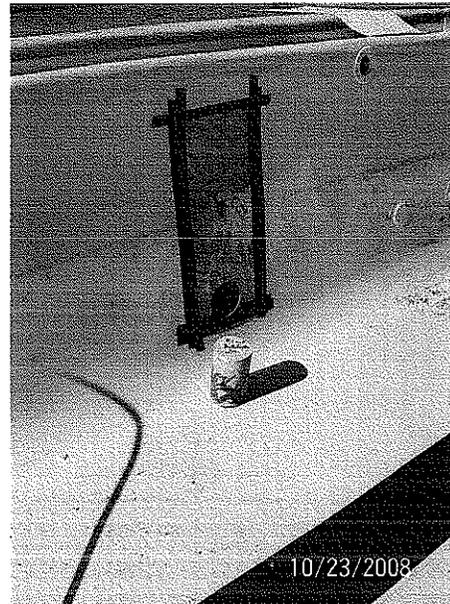
Figure 14

Walls: Two (2) 6-inch Borings were taken. The walls range between 8 ½ inches and 9 ¼ inches thick. Samples indicate Steel Reinforced Gunite Type Concrete Construction. See Fig. 14.
